Seismic Performance Evaluation of Nonstructural Components: Drywall Partitions

Tae-Hyung LEE, Mikiko KATO*, Tomohiro MATSUMIYA, Keiichiro SUITA,
and Masayoshi NAKASHIMA

Synopsis

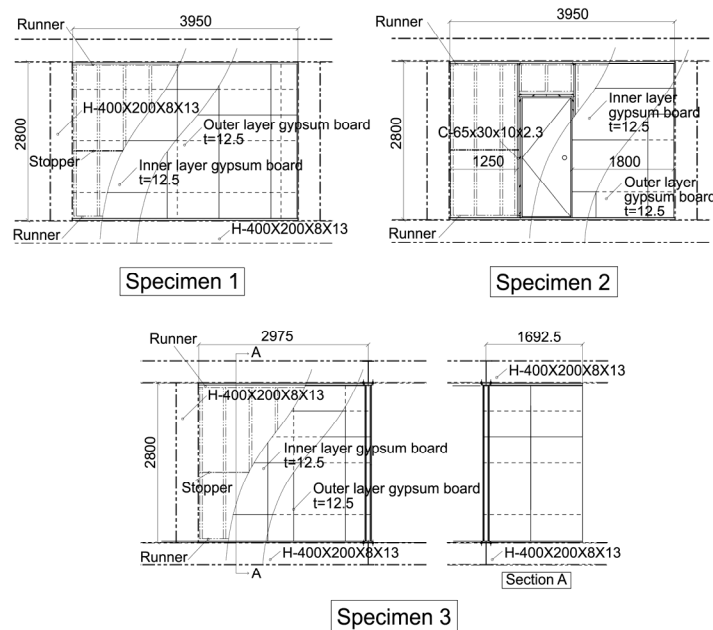
Fig. 2 Design details of specimens (unit: mm).

Four drywall partitions were built for the present experimental study. Fig. 2 shows design details of these specimens. Specimen No. 1 is a plain drywall partition with the dimensions of 2800mm (height) by 3950mm (width), constructed with the procedure described in the previous section. Specimen No. 2 is a drywall partition with a door (850mm by 2100mm). The wall dimensions are identical to those of specimen No. 1. Specimen No. 3 consists of two walls intersecting each other at a 90-degree angle. The width of the main wall (parallel to the loading direction) is 2975mm and that of the intersecting wall (orthogonal to the loading direction) is 1600mm, while the height of both walls is 2800mm.

Specimen No. 4 was constructed to study the effect of dynamic loading whose design is identical to Specimen No. 1. For base channels, this study used Japanese Industrial Standard 65 type; for runner, WR-65 (67X40X0.8); for stud, WS-65 (65X45X0.8); for stopper that connects studs laterally, WB-25 (25X10X1.2). The gypsum board whose dimensions are 910mm by 1820mm with 12.5mm thickness is made of gypsum and finished with paper on one face.

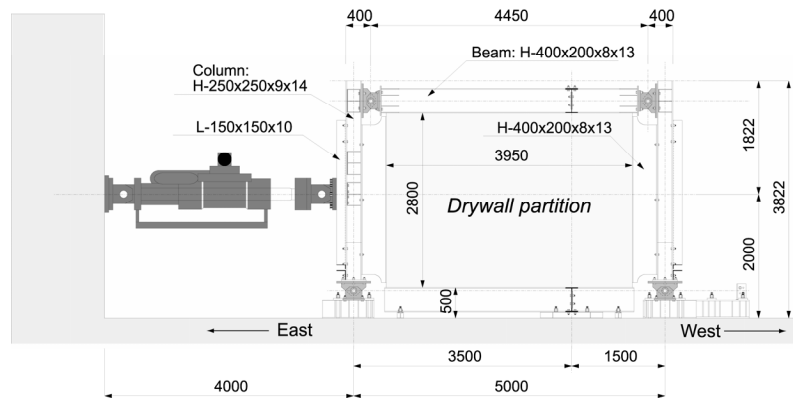
Fig. 3 Test setup (unit: mm).

It is assumed that the most critical structural response to partition walls is the story drift. Accordingly, the test setup is designed such that pure shear loading, either static or dynamic, is applied to the test specimen. Fig. 3 depicts the schematic of the test setup and its various details. The specimen was mounted on pin-connected beams and columns such that base channels were attached to the top and bottom beams. The clearance of 15mm between the drywall partition and the column was provided on each side (East and West) for all specimens except Specimen No. 3 where it applied only to the east side of the specimen. The hydraulic actuator was connected to the east column to provide the lateral loading.

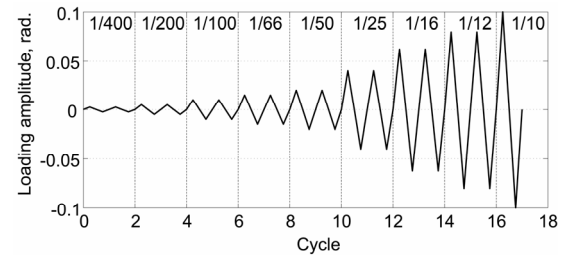
Fig. 4 Cyclic loading protocol.

Fig. 4 shows the sequence of quasi-static cyclic loading. It applies to all specimens except for Specimen No. 4. After reaching the peak deformation of each cycle, both positive and negative, and reaching zero deformation, damage was inspected and recorded. A series of sinusoidal loading, two cycles with the period of 1 second (one cycle) and the amplitude of 1/400, 1/200 ... and 1/10, the same as those specified in Fig. 4, was applied to specimen No. 4. At the end of each loading amplitude, i.e., every two cycles, damage to the specimen was inspected and recorded.

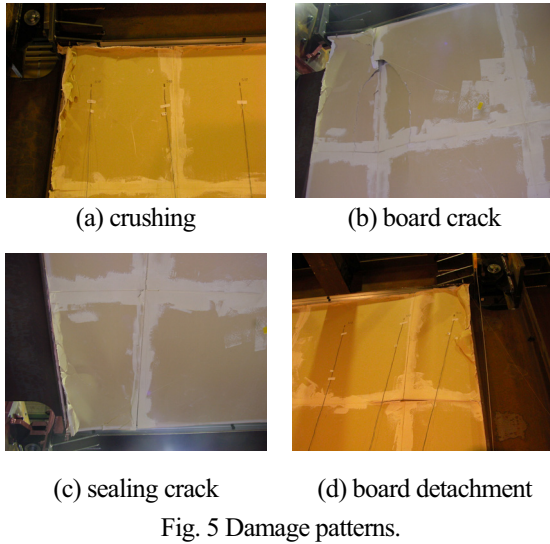
Fig. 5 Damage patterns.

This section describes the damage to the specimens observed by eyeball inspection, which is followed by the analysis of strain measurements. Observed damage patterns include crushing of boards, sealing cracks, board cracks, and out-of-plane deformation of boards whose parts around screws were crushed. Fig. 5 shows pictures of various damage patterns of the drywall partition.

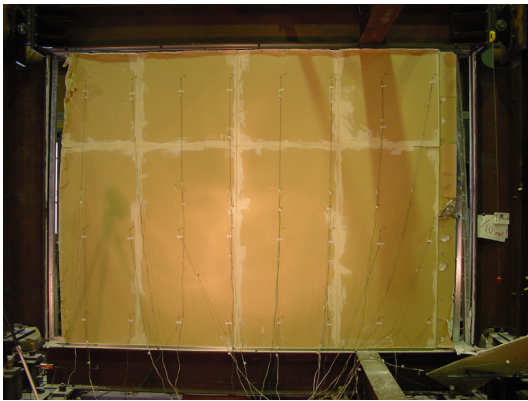
Fig. 6 Specimen No. 1 after the test.

side) in addition to the initial gap of 15mm on the other side prevented the partition from being damaged up to 30mm of the story drift that corresponds to 0.01 rad (30mm/2800mm). At 0.015 rad story drift, a room for the sliding was not available any more due to geometry and the column started to crush the neighboring gypsum board. Damage to the specimen is mainly due to compressions from the columns and beams, rather than the shear force. Fig. 6 shows a picture of Specimen No. 1 at the end of the last loading.

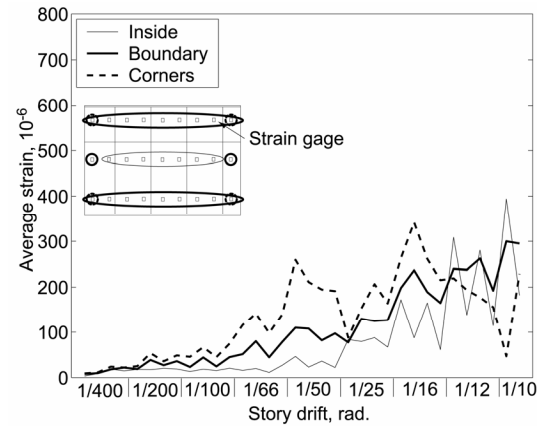
Fig. 7 Average strains of Specimen No. 1.

It is noted that the damage is concentrated at the boundaries of the partition, particularly the four corners, while the inside portion of the partition only suffers from relatively minor damage. To support this argument, the average strains of the inside portion, the boundary and the four corners of the partition are compared in Fig. 7(a),

in which the values corresponding to peak rotations are plotted. The average strain of the boundary of the partition is more than twice as high as that of the inside up to the 0.06 rad story drift, where severe damage to the gypsum boards fails some of the strain gauges at the boundary. Moreover, the average strain of the four corners is about 50% higher than that of the boundary. Damage to Specimen No. 1 is depicted in Fig. 8 where the number in parentheses designates the loading amplitude in radian at which the corresponding damage occurs.

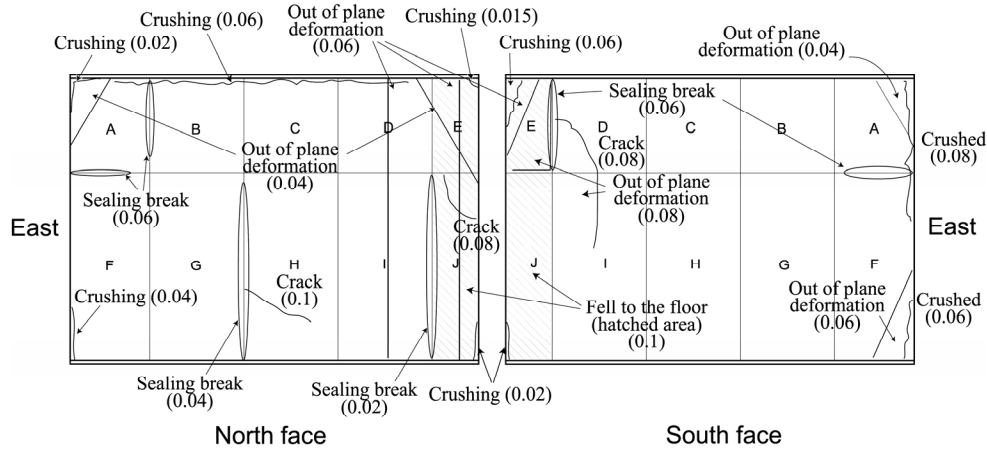
Fig. 8 Damage to Specimen No. 1.

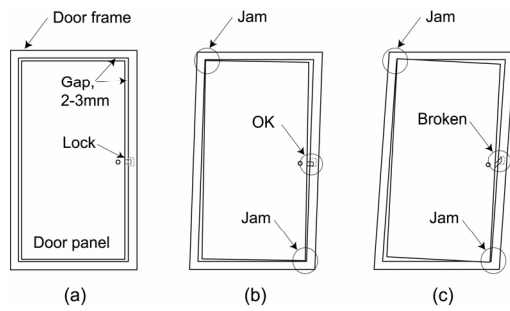
Fig. 9 Functionality of the door in the drywall partition; (a) initial configuration of the door; (b) deformation of the door under 0.01 rad story drift; (c) deformation of the door under 0.02 rad story drift.

The feature of Specimen No. 2 is the door in the partition. The functionality of the door is of interest as well as damage to the partition for the safety issue. During the test, the door was jammed at story drift of 0.01 rad. As shown in Fig. 9(a), the gap exists between the door panel and the doorframe. At the story drift of 0.01 rad that causes 0.006 rad shear distortion of the doorframe itself, the gap was closed because of the rotation of the door panel to cause the door to jam, as shown in Fig. 9(b). However, when the load was removed to the zero story drift, the door panel and the doorframe recovered their original shapes and the door was working. At the story drift of 0.02 rad, the door lock was broken as well as the door jammed due to the door panel's rotation, as shown in Fig. 9(c). It was not recovered even at the zero story drift and the door was permanently jammed. It is noted that the shear distortion of the doorframe that caused this was 0.01 rad.

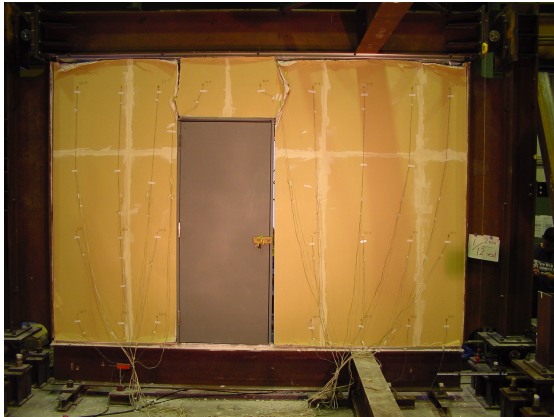
Fig. 10 Specimen No. 2 after the test.

Fig. 10 shows a picture of Specimen No. 2 after the test. It is clearly visible that the entire partition is completely divided into three panels by cracks: the left, above, and right side of the door. Fig. 11 shows the comparison of the average strains of the inside, boundary, and corners of the partition. Similar to Specimen No. 1, the corners suffer from higher strain than the other part of the partition up to the story drift of 0.02 where some of

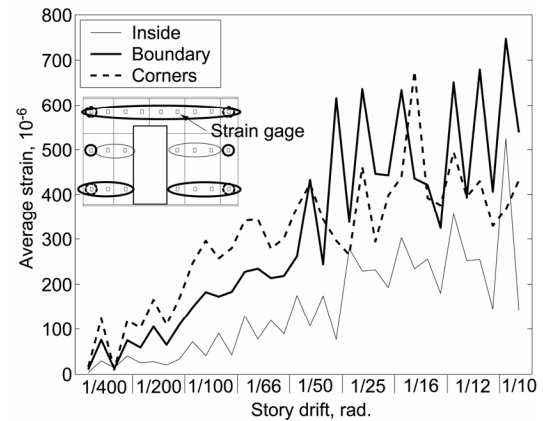
Fig. 11 Average strains of Specimen No. 2.

the strain gauges at corners failed due to damage. Moreover, the boundary of the partition shows 150% higher strain than the inside. Damage to Specimen No. 2 is depicted in Fig. 12.

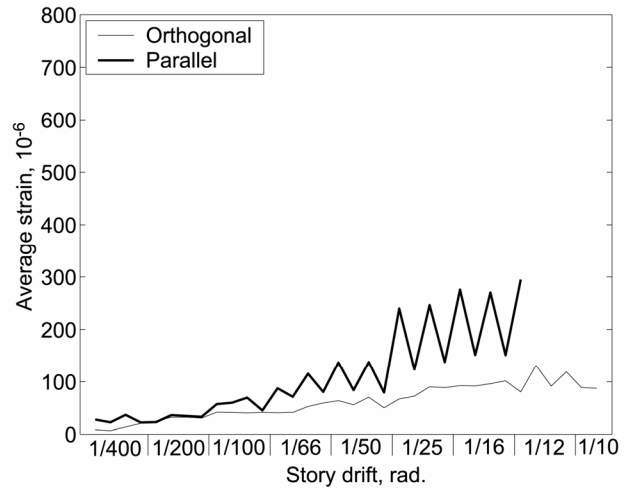
Fig. 14 Average strains of Specimen No. 3.

Fig. 14 shows average strains of the parallel and orthogonal partitions. It should be noted that strain measurements near the intersection of the two partitions are excluded in the computation of the average strains. The average strain in the parallel partition is twice as high as that in the orthogonal partition. Damage to Specimen No. 3 is depicted in Fig. 15.

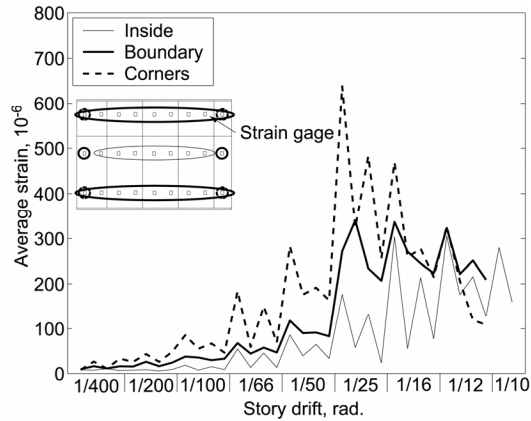
Fig. 16 Average strains of Specimen No. 4.

amplitude of the story drift). The damage pattern is similar to that of Specimen No. 1 where the boundary of the partition is more damaged than the inside of the partition. Moreover, two gypsum boards were completely detached from the studs and fell to the floor. Fig. 16 shows average strains of the boundary, inside, and four corners of the partition. The trend of the plot is comparable to that of Specimen No. 1 in Fig. 7. A picture of Specimen No. 4 at the end of the test is shown in Fig. 17. Damage to Specimen No. 4 is depicted in Fig. 18.

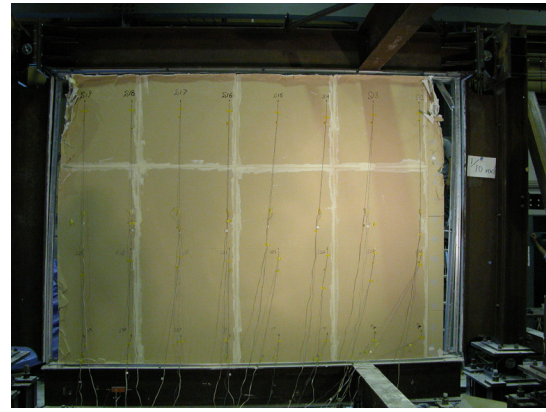
Fig. 17 Specimen No. 4 after the test.

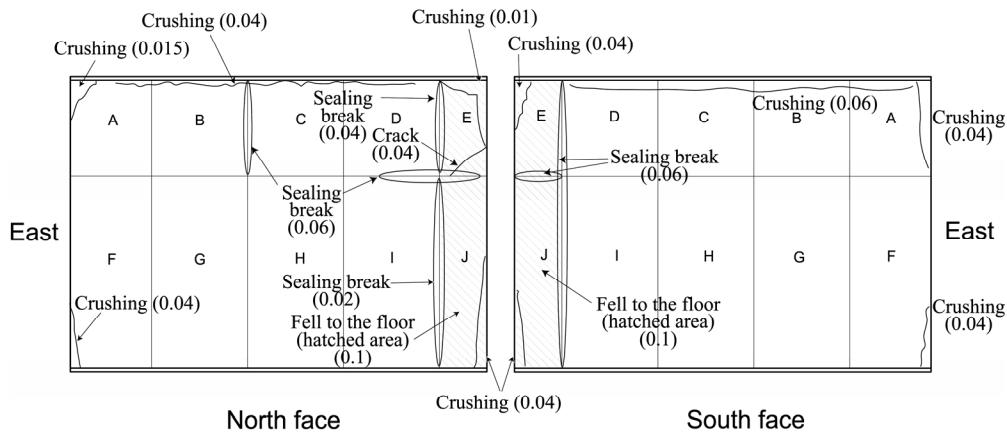
Fig. 18 Damage to Specimen No. 4.

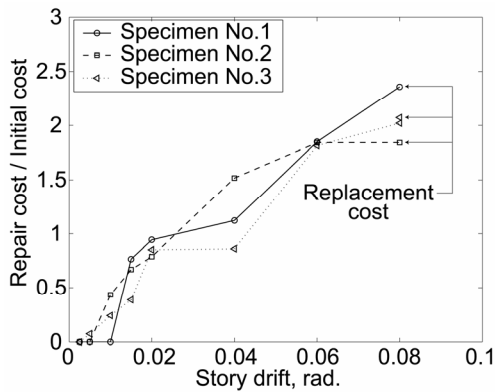
Fig. 19 Damage-repair cost relationship.

Fig. 19 shows the ratio of the repair cost to the initial cost (referred to as the cost ratio) for Specimen Nos. 1, 2, and 3 with respect to the story drift. The initial cost includes two layers of gypsum boards, base steel frames, runners and studs, and the labor expense. The repair cost refers to the cost to replace the damaged part of the partition. It includes necessary material and labor expenses to repair the partition and the removal and disposal of the damaged part of the partition, so that the replacement cost exceeds the initial cost. It is noted that the initial costs of Specimen Nos. 2 and 3 are 77% and 19% higher than that of Specimen No. 1, respectively.

Specimen No. 1 need not be repaired as long as the story drift is not greater than 0.01 rad because it only slid without being damaged. Therefore, at story drifts of 0.005 rad and 0.01 rad, which are considered the expected demands for Levels 1 and 2 earthquakes in Japan, respectively, no repair was needed. At the story drift of 0.02 rad, the cost ratio is already as high as 0.94. At the story drift of 0.04, the repair cost exceeds the initial cost. From the story drift of 0.015 to 0.04 rad, only

gypsum boards are to be replaced. At the 0.06 rad story drift, all parts except for the base steel frame are to be replaced. After the 0.08 rad story drift, the whole wall needs to be replaced and the cost ratio is 2.36.

Specimen No. 2 need not be repaired as long as the story drift is not greater than 0.005 rad. Some cracks were observed at the story drift of 0.005, but they were considered insignificant and not requiring repair. At the story drift of 0.01 rad, the cost ratio is 0.43. The cost ratio is 0.79 at the story drift of 0.02 rad, which includes the replacement of the doorknob. At the story drift of 0.04 rad, the repair cost exceeds the initial cost. After the 0.04 rad story drift, the door needs to be replaced, which causes an additional rise in the repair cost. It is noted that 50% of the initial cost of this specimen is the installation of the door. After the 0.06 rad story drift, the whole partition needs to be replaced and the cost ratio is 1.84.

Specimen No. 3 needs to be repaired as long as the story drift is greater than 0.0025, which is earlier than any other specimen. This is caused by the damage to gypsum boards and joint mixtures near the intersection of the parallel and orthogonal partitions. At the story drift ratios of 0.005 rad and 0.01 rad, the cost ratios are 0.08 and 0.24, respectively. At the story drift of 0.02 rad, the cost ratio is 0.85. From the 0.02 to 0.04 rad story drift, the orthogonal partition also needs to be repaired. From the 0.06 rad story drift where the repair cost exceeds the initial cost, almost all parallel partition needs to be repaired. However, this specimen does not require the whole replacement of the partition whose cost ratio is 2.02 because some parts of the orthogonal partition are intact.

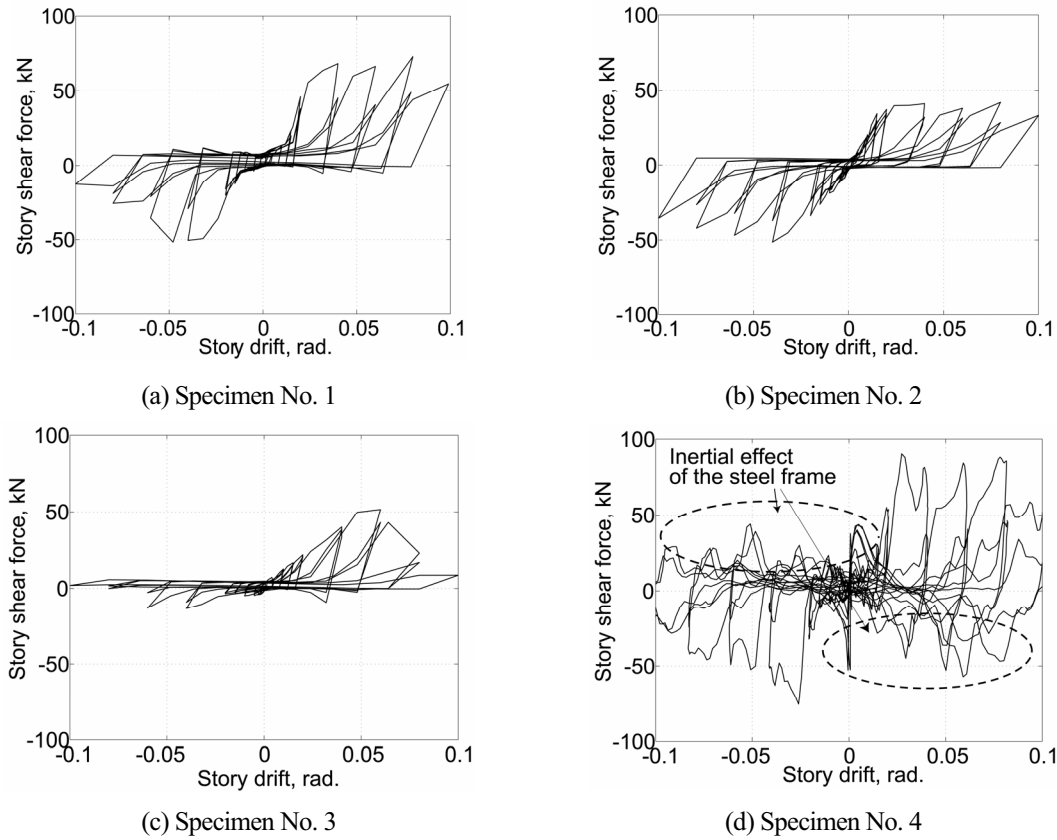
Fig. 20 Story shear force vs. story drift relationships.

During the test, the load in the jack and the corresponding displacement that is under control are measured to investigate the load-displacement relationship of the specimen. The relationship between the story shear force and story drift for each specimen is shown in Fig. 20. The most important characteristics of the load-displacement relationship are pinching and stiffness degradation. Strength degradation is also observed in all three specimens where those of Specimen No. 1 in the negative loading and of Specimen No. 3 in the positive loading direction are distinctive.

The load-displacement relationships of all three specimens are not symmetrical with respect to the loading direction. As shown in Fig. 20(a), peak strengths in the positive loading direction at each loading cycle are higher than the counterparts in the negative direction for Specimen No. 1. Moreover, the strength degradation in the negative direction is more severe than that in the positive direction. It is partially attributed to the notion that gypsum boards damaged in positive loading do not fully contribute to the corresponding load-carrying capacity in the negative direction.

loading direction at each loading cycle are lower than their counterparts in the negative direction as shown in Fig. 20(b). In the positive loading, gypsum boards on the eastern side of the door act as the load-resisting component because the doorframe is fixed to the base channel and serves as the bearing support to the partition as shown in Fig. 21(a). On the other hand, when the load is reversed, gypsum boards on the western side of the door play the same role [Fig. 21(b)]. The difference in the bearing area at the bottom of the wall (1250mm and 1800mm for the positive and negative loadings, respectively) is likely to have caused the difference in the

Fig. 20(d) for Specimen No. 4 shows inertial effect of the steel frame where the story shear force is increased when the loading direction is changed. However, it does not affect the damage of the wall as described earlier.

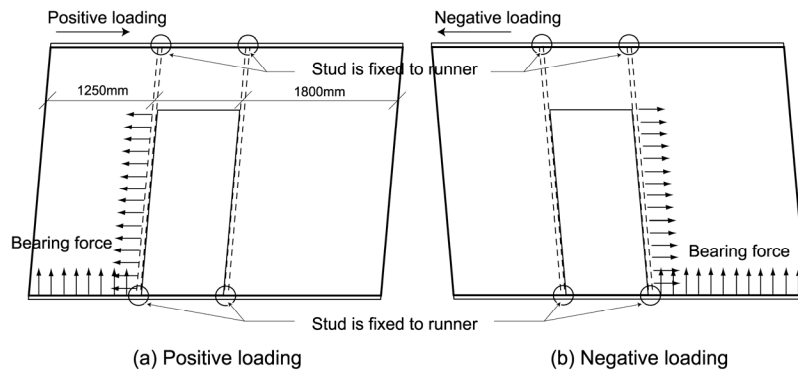
Fig. 21 Load-resisting mechanism of Specimen No. 2.

peak strength. Severe strength degradation is not observed, because the doorframe always acts as the bearing support in both directions.
